S-303
Sea Isle Furniture
Crisfield
public

Survey No. S-303

Maryland Historical Trust State Historic Sites Inventory Form

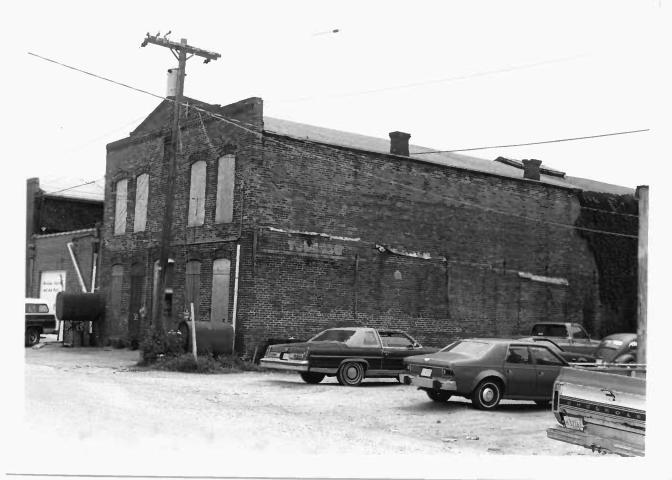
Sea Isle Furniture S-303 Crisfield, Somerset County Southwest Elevation 8/85, Paul Touart, Photographer Neg./Md. Historical Trust

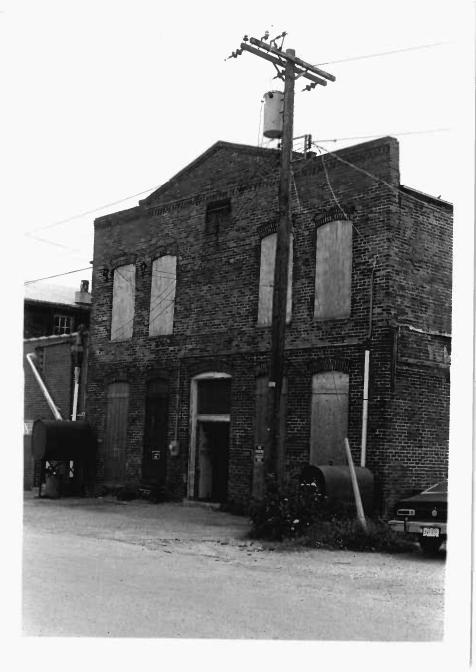
Sea Isle Furniture S-303 Crisfield, Somerset County Southwest elevation 8/85, Paul Touart, Photographer Neg./Md. Historical Trust
